United Nations A/67/997–S/2013/553

Report of the United Nations Mission to Investigate Allegations of the Use of Chemical Weapons in the Syrian Arab Republic on the alleged use of chemical weapons in the Ghouta area of Damascus on 21 August 2013

Report on Allegations of the Use of Chemical Weapons in the Ghouta Area of Damascus on 21 August 2013

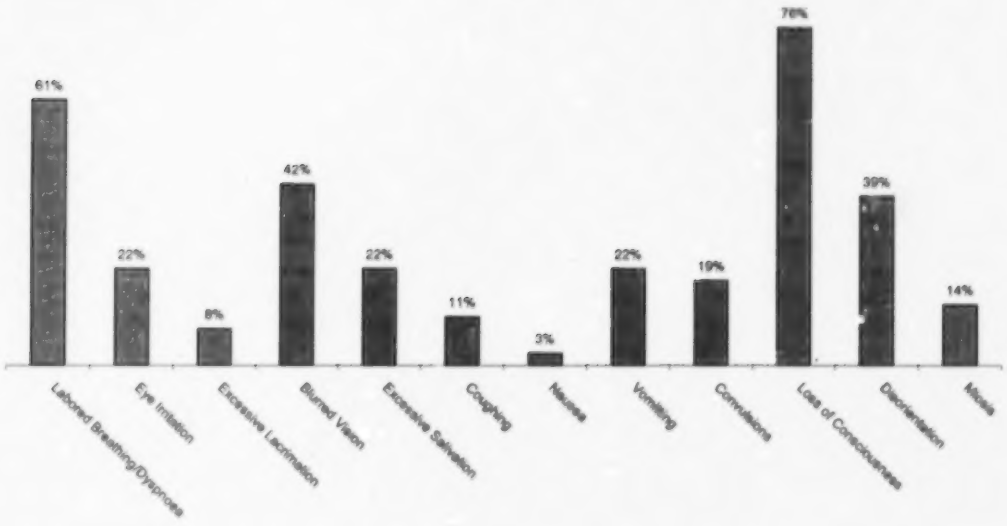
Chart: Symptoms and signs of survivors (N=36)

The main symptoms reported by survivors included loss of consciousness (78%), shortness of breath (61%), blurred vision (42%), eye irritation/inflammation (22%), excessive salivation (22%), vomiting (22%), and convulsions/seizures (19%). The full range of symptoms and signs are presented in the chart below.

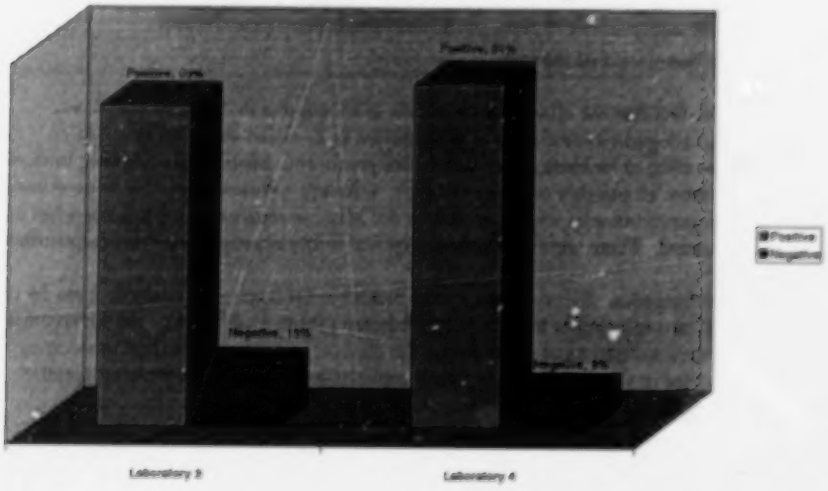
Results of Plasma testing

Conclusion. The positive blood and urine specimens provide definitive evidence of exposure to Sarin by a large proportion of the survivors assessed by the investigation Mission. These results are corroborated by the clinical assessments, which documented symptoms and signs that are consistent with nerve agent exposure, including shortness of breath, eye irritation, excessive salivation, convulsions, confusion/disorientation, and miosis. The findings of the clinical assessments were consistent with information derived from both the interviews with clinicians and the review of medical records, which each reported symptoms and signs consistent with nerve agent exposure.

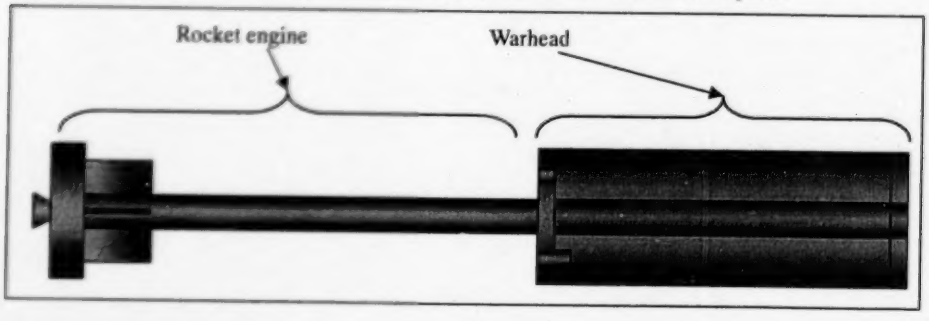
Below is a drawing of the found ordnance, the body has been divided into two parts.

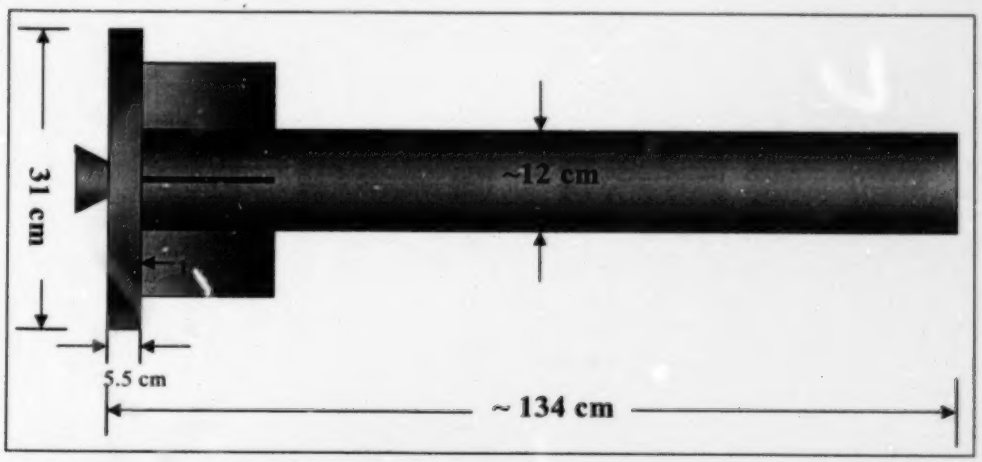
The rocket engine:
Six stabilizer fins are equally arranged in a circle and stabilized with a metal ring.
One rocket had a red number 153 sprayed in the middle of the engine tube.
The engine tube is attached to the warhead with 12 bolts.

- Total length of the engine: ~134 cm (exit nozzle not included)
- Length of rocket motor fins: ~16.5 cm
- Width of stabilizing ring: ~5.5 cm
- Length of motor exit nozzle: ~4.5 cm
- Length of motor engine shaft: ~112 cm
- Ø of engine shaft: ~12 cm
- Ø of stabilizer ring: ~31 cm

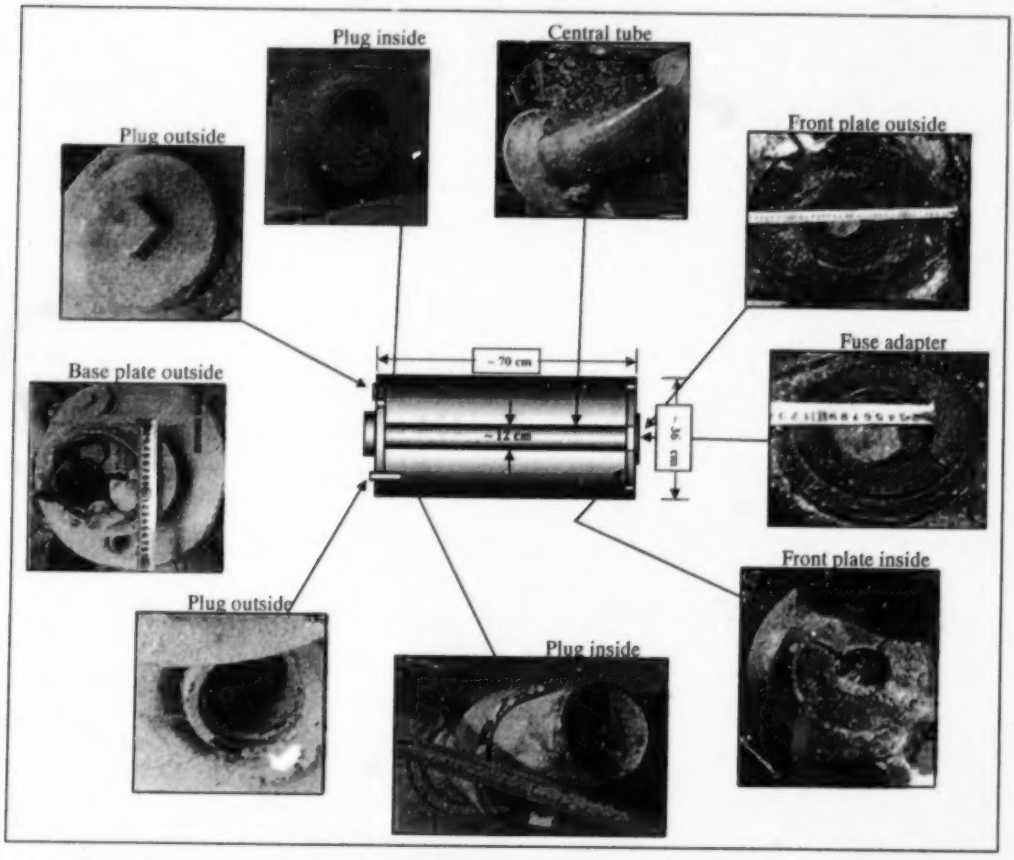
The warhead consists of:

- Front metal plate with a fuse thread in the center
  - Ø outside: ~ 36 cm
  - Ø fuse thread: ~ 9 cm

- Six threaded attachment holes are equally arranged in a circle near the outer ring

- Body / outer container consisting of metal plate
  - Thickness ~ 5 mm
- Metal base plate with filling plug, tube and attachment ring with 12 bolts.
  - Ø outside: ~ 36 cm
  - Ø square bolt ~ 7 cm
  - Ø integrated tube on the base plate ~ 3 cm
  - Length of the tube ~ 10 cm
- Central tube of the warhead
  - Length of tube: ~ 70 cm
  - Ø of the tube: ~ 12 cm

Liquid capacity of the warhead:
The approx. capacity of liquid in the warhead is according to the measurements between 56 ± 6 liters. This calculation is exclusive to the thickness of the container walls and any other unknown components possibly contained in the warhead.

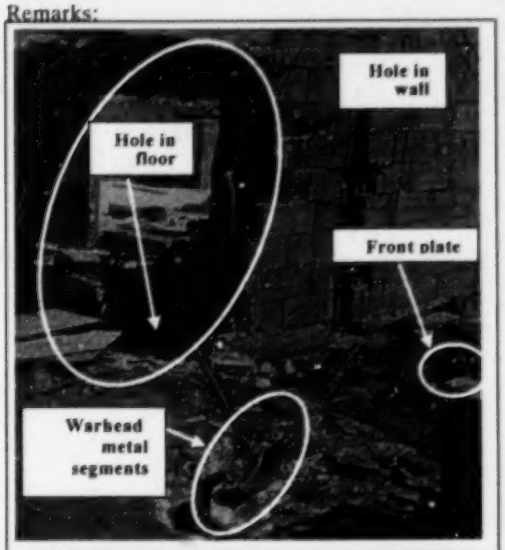
1. The rocket found by the sub-team on the roof penetrated a cinderblock wall and a rebar containing concrete floor before coming to rest in a room below. The suspected front plate of the warhead and other parts suspected of being the warhead casing were found in front of the first wall and not in the lower room. Additionally, they did not exhibit signs of significant deformation or damage due to kinetic impact. Based on the found evidence; there is an indication that the rocket warhead appeared to function prior to impacting on the roof, releasing its contents and depositing the discovered fragments before travelling through the structure to its terminal location. Apart from the rocket motor and the front central tube with the base plate, no other munition fragments were found in the lower room.

2. The front plate showed 6 symmetric threaded holes around the outline. It's unclear what part(s) are attached through these holes.
